Mobile Intel® Celeron® Processor at 466 MHz, 433 MHz, 400 MHz, 366 MHz, 333 MHz, 300 MHz, and 266 MHz Specification Update

Release Date: March 2002

Order Number: 244444-030

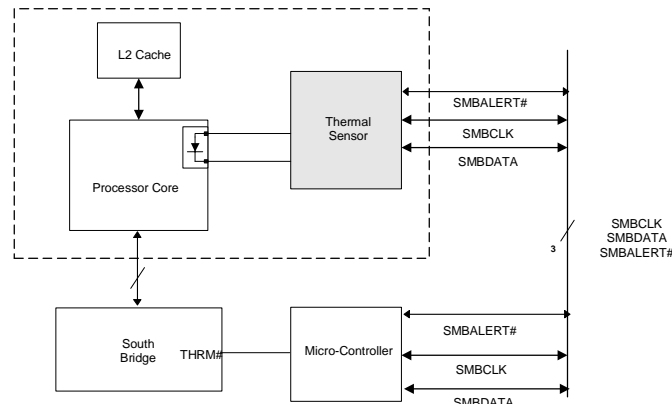
Figure 1. An Example of Microcontroller Driven Thermal Management

H29. Thermal Sensor May Assert SMBALERT# Incorrectly

Problem: The Intel Celeron Processor Mobile Module has a thermal sensor that monitors the processor core's temperature. Please note that desktop systems could have a similar thermal device. The thermal sensor asserts SMBALERT# if the processor temperature exceeds the temperature limits set in the Alarm Threshold Registers (T_{HIGH} , T_{LOW}). It also sets the corresponding Status Register bits to identify the cause of the interrupt. Figure 1 gives one example of the how the SMBALERT# signal could be used in a system.

Implication: There is no system impact from this erratum if temperature polling is used for processor thermal management. If the SMBALERT# interrupt is employed to manage processor thermal sensing, then servicing the false interrupt may result in premature system action depending on the software and hardware implementations used. The rate of the false interrupts is less than the auto-convert rate of the thermal sensor.
